# **CERTS MICROGRID LABORATORY TEST BED**

Test Plan Section 7.0  
Validate Protection Settings and  
Initial Fault Testing

# **CERTS MICROGRID TEST REPORT**

*“Validate Protection Settings and Initial Fault Testing”*

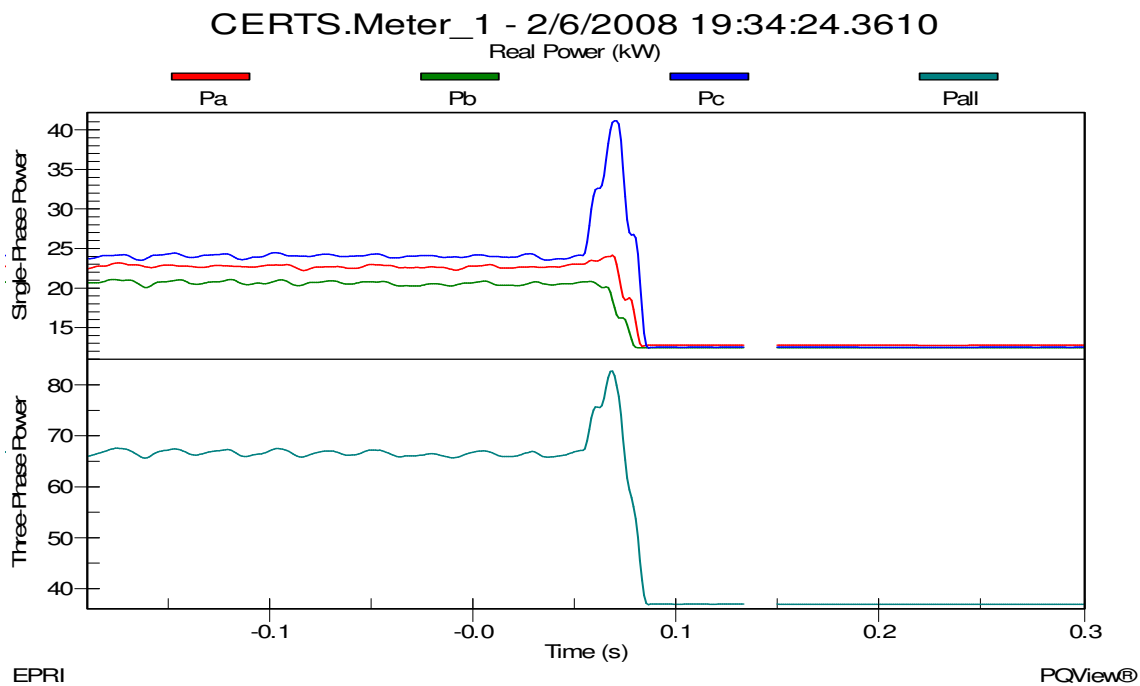
After both Gen-sets A1 and B1 were running for a few minutes and supplied power to Load Banks 3 and 4, the test was started with a “Start” command from the EMS. As soon as the static switch closed and steady-state conditions established, the microgrid and Load Bank 6 were connected to the utility grid with the total power flow at Meter 1 being approximately 68kW, shown in Figure 19a, and approximately 32kW at Meter 2, shown in Figure 19b. Gen-sets A1 and B1 were producing about 20kW each, shown in Figures 19c and 19d before the fault was applied after 0 seconds.

**Figure 19a Meter 1 power flow before/after the static switch opened, islanding the microgrid from the utility grid when a single phase-to-ground fault was applied in Zone 2.**

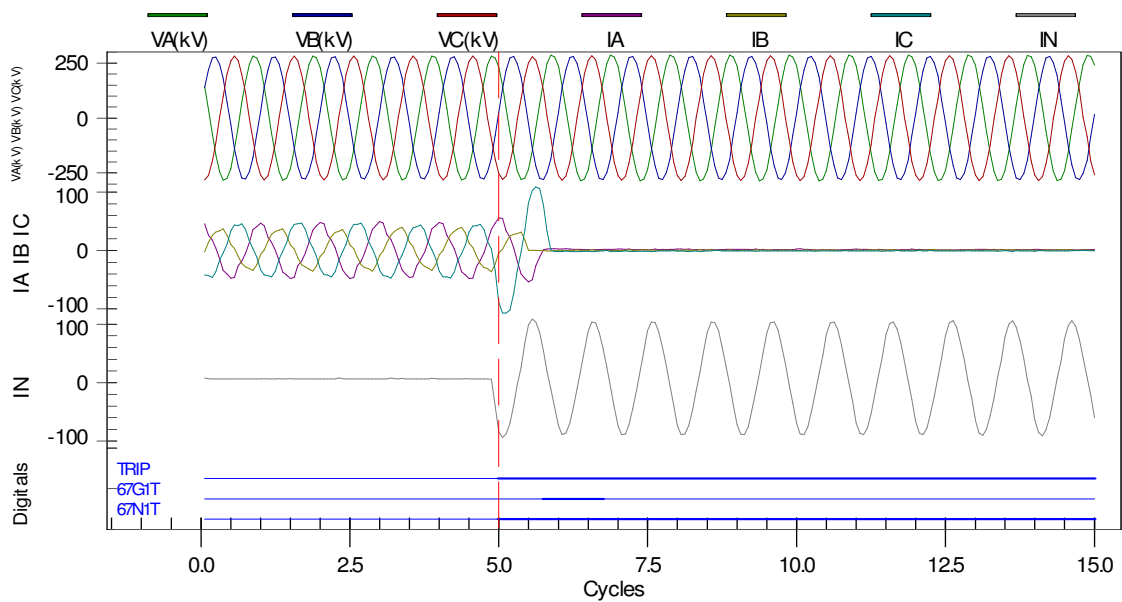
**Figure 19e - Relay 2 (static switch) tripped due to a ground over-current (67N1T) when the single phase-to-ground fault was initiated in Zone 2.**

Using the DAS Load Control program, the single phase-to-ground fault on C-phase was set for 10 seconds and then initiated. Relay 2 tripped the static switch first on ground over-current (67N1T) in approximately 0.02 seconds (1 cycle) after the fault was applied, Figure 19e. Both Gen-sets A1 and B1 ramped up carrying Load Banks 3 and 4, as well as the C phase overload fault. Relay 3 tripped approximately 0.17 seconds (10.4 cycles) after the static switch opened, causing Gen-set A1 to stop switching its output, although its transformer contactor and CB31 remained closed for a few cycles longer. This can be seen by the reverse power on A and B phases supplying C phase even though the net three phase power remains zero, Figure 19c. CB31 opened 0.046 seconds (2.75 cycles) after receiving the trip signal from Relay 3, separating Zones 3 and 4 from the microgrid.

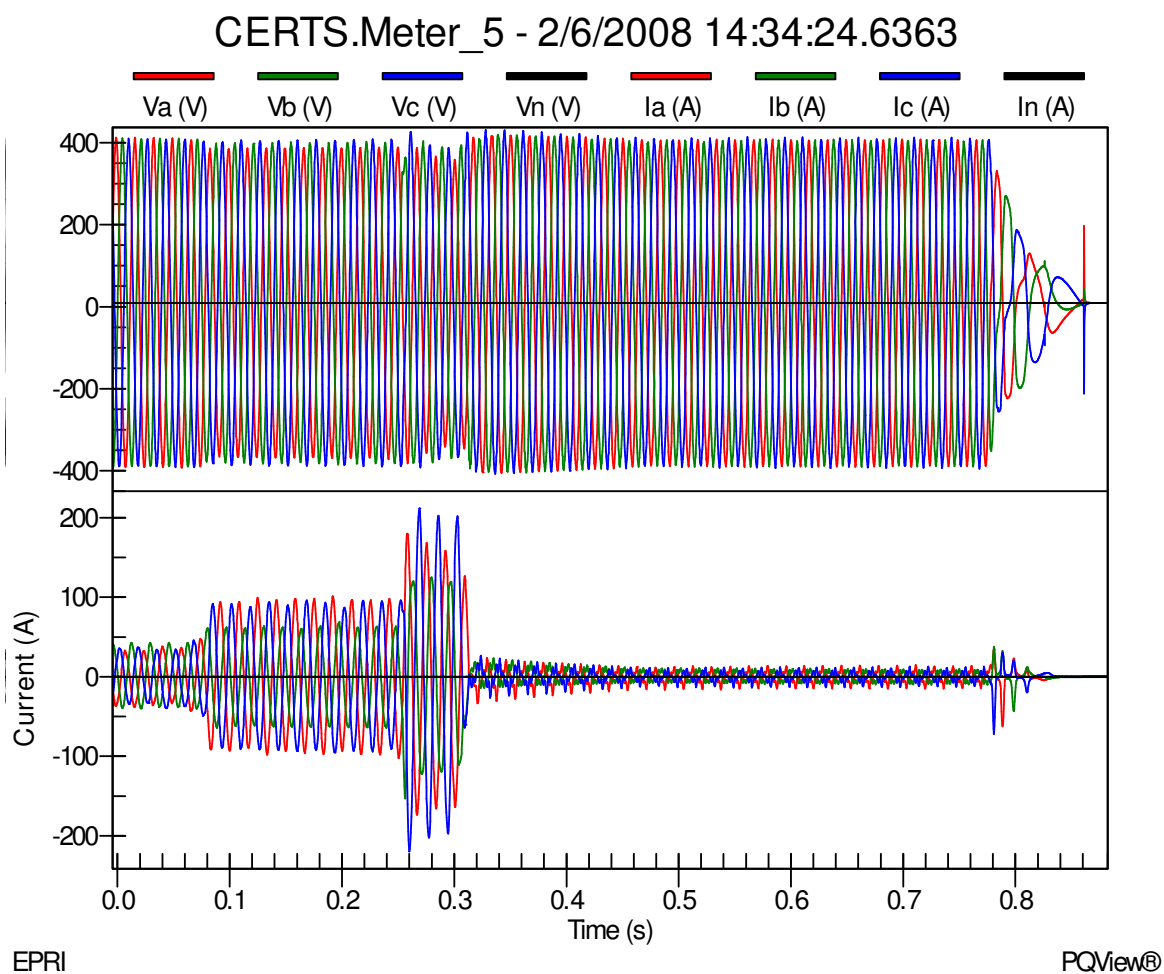
Figure 19f - Meter 5 voltage and current during the applied single-phase-to-ground fault in Zone 2.

Gen-set B1 remained on-line supporting the fault load bank in Zone 2, Figure 19f. Because the static switch and CB31 were now open, Zone 2 was dominated by the Delta winding of T51 and effectively turned the entire zone into a 3-wire system. However, the measurement transformers which feed the DSP controller and the under-voltage relay 5a were connected wye-wye and likely experienced a full phase to phase voltage (480V) across their primary windings (277V), Figure 19g. Because only high impedance measurement equipment was connected to the secondaries of these transformers, negligible fault current flowed through them. Since the fault was applied from C phase-to-ground there remained no path for current flow and the fault was effectively removed.

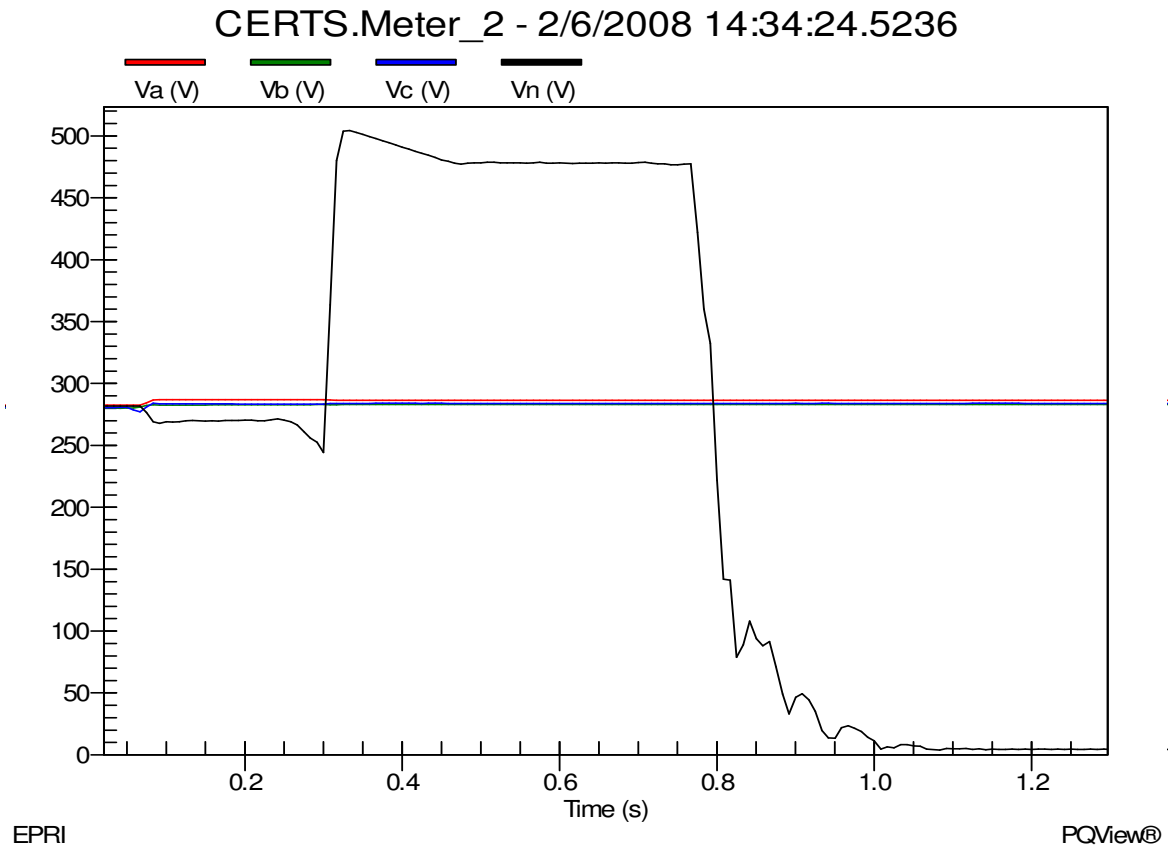
Figure 19g – Meter 2 RMS voltage before/after CB31 opened.

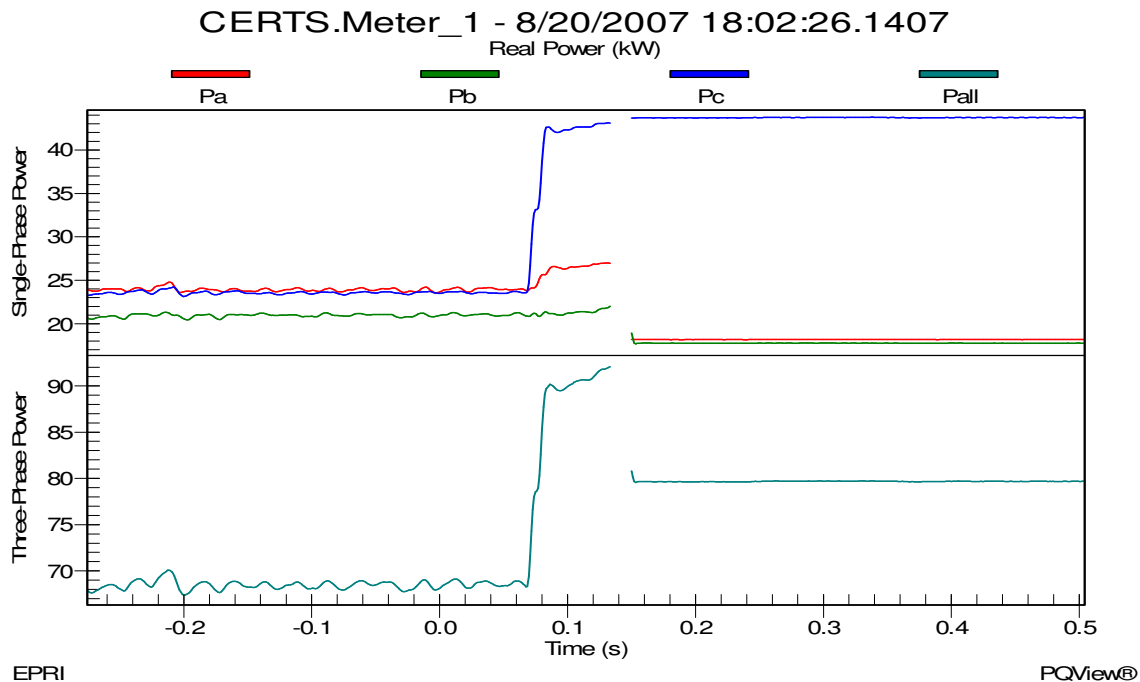
**Figure 20a - Meter 1 power flow before/after the static switch opened, islanding the microgrid from the utility grid when a single phase-to-ground fault was applied in Zone 6.**

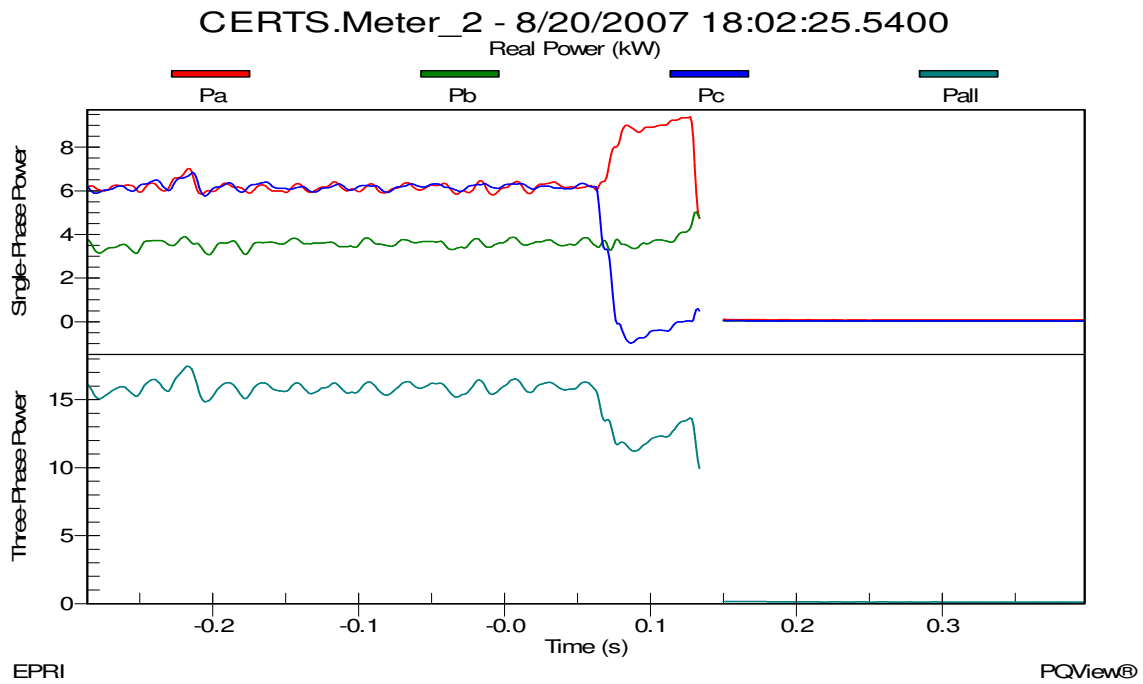
Figure 20b - Meter 2 power flow before/after the static switch opened, islanding the microgrid from the utility grid when a single phase-to-ground fault was applied in Zone 6.

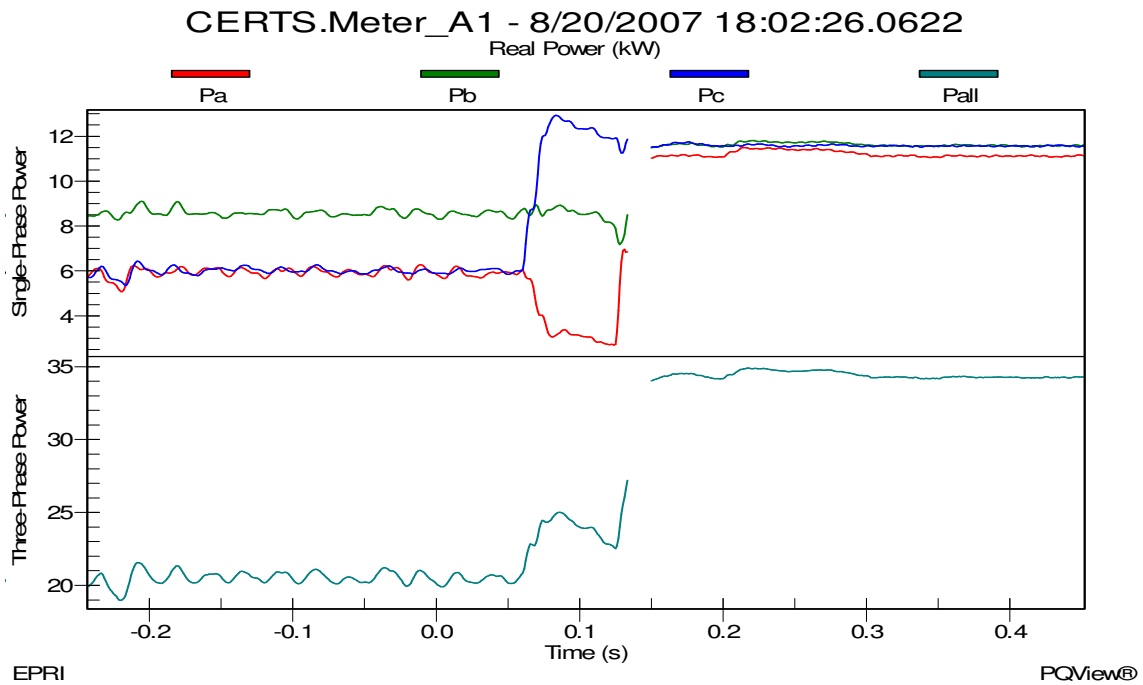
Figure 20c - Power produced by Gen-set A1 before/after the static switch opened from a C-phase phase-to-ground fault in Zone 6.

After Gen-set A1 was running for a few minutes and supplied power to Load Bank 3, the test was started with a “Start” command from the EMS. As soon as the static switch closed and steady-state conditions established, the microgrid and Load Bank 6 were connected to the utility grid with the total power flow at Meter 1 being approximately 68.5kW, shown in Figure 20a, and approximately 16kW at Meter 2, shown in Figure 20b. Gen-set A1 was producing about 20.5kW, shown in Figures 20c before the fault was applied after 0 seconds.

A few points of interest for this test include the Gen-set contribution to the fault and the sensitivity of the static switch to an unbalanced load within the unprotected portion (i.e., Zone 6) of the microgrid. In Figure 20c it can be seen that at Meter A1, just after the fault was applied, three phase power increased slightly from 20kW to 25kW, with C-phase output increasing and A-phase output decreasing. Because the three phase power increased by approximately 5kW, it must be concluded that Gen-set A1 did increase its power output. The reduction in A-phase power which contributed to the C-phase

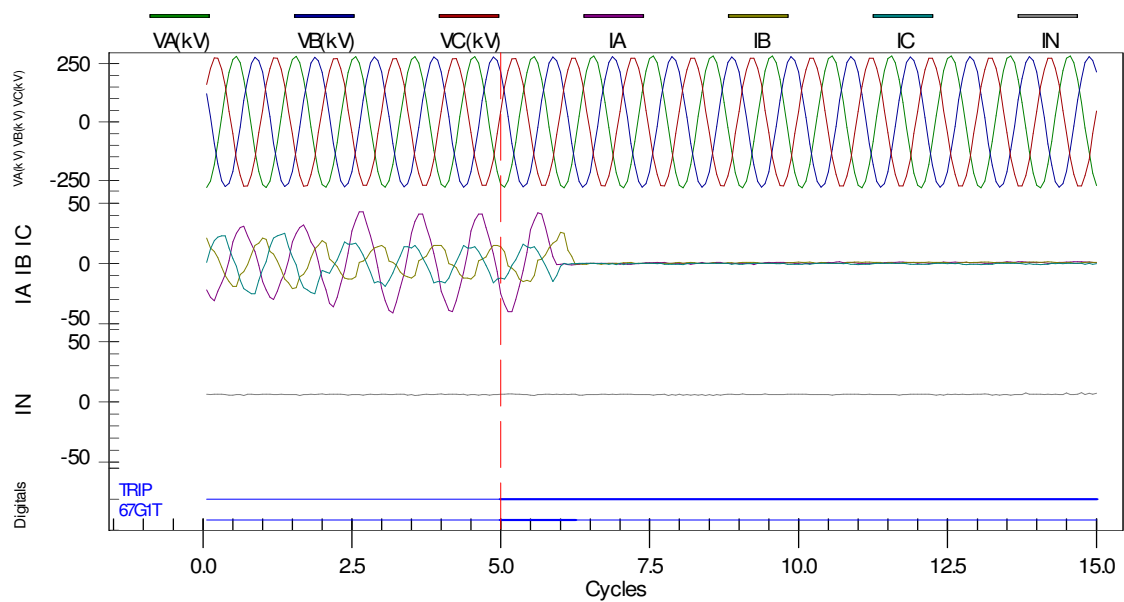
**Figure 20d - Relay 2 (static switch) tripping due to a ground over-current (50GR) when the single phase-to-ground fault was initiated in Zone 6.**

Using the DAS Load Control program, the single phase-to-ground fault on C-phase was set for 10 seconds and then initiated. The static switch tripped in approximately 0.07 seconds (~4.3 cycles) from a neutral over-current (67G1T), shown in Figure 20d, islanding the microgrid from the utility grid. Following the static switch operation, CB13, which provides protection to Zone 6, tripped on  $I^2t$  protection with CB31, CB41 and CB51 remaining closed, since the overload fault was not part of the microgrid, located beyond the static switch.

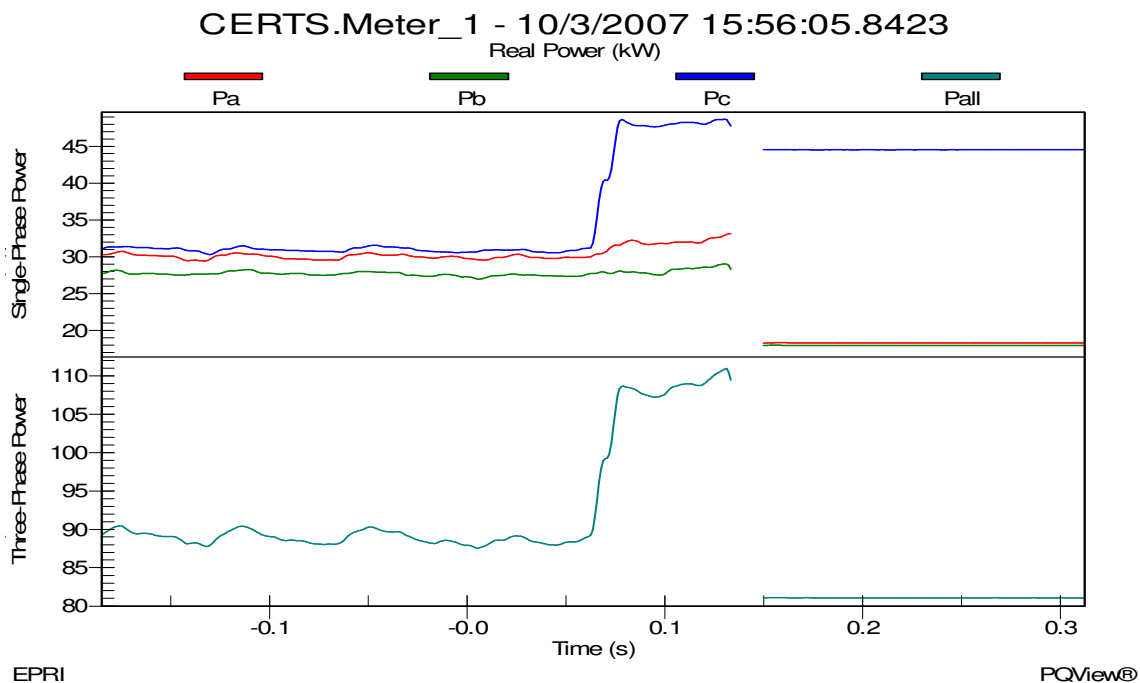
Figure 21a Meter 1 power flow before/after the static switch opened, islanding the microgrid from the utility grid when a single phase-to-ground fault was applied in Zone 6.

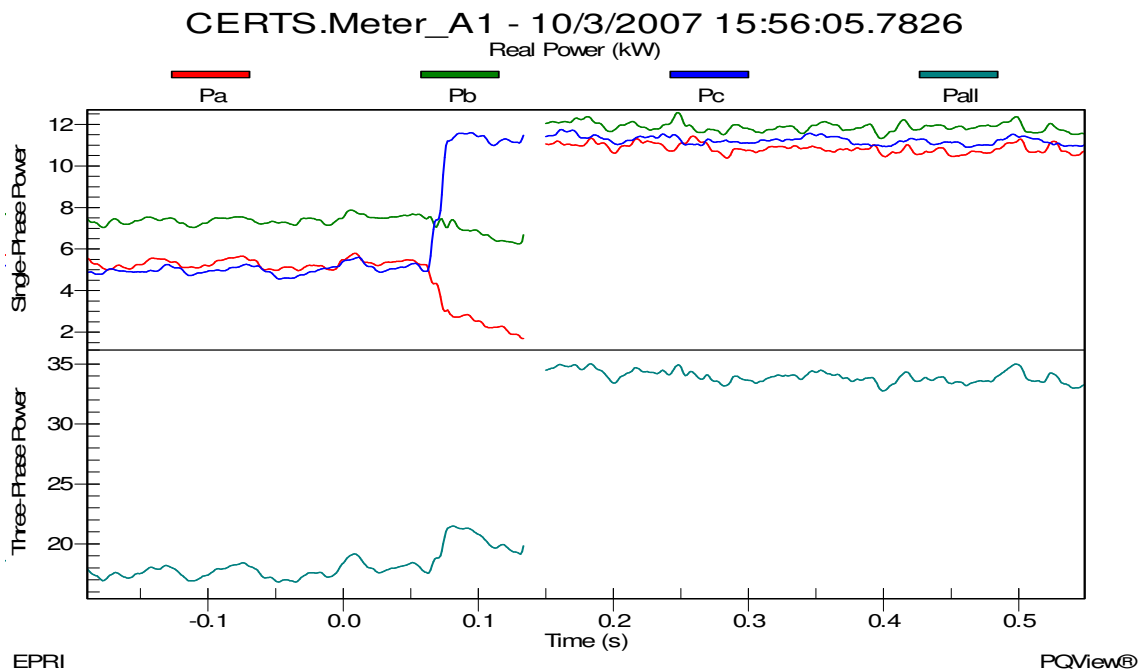
Figure 21c - Power produced by Gen-set A1 before/after the static switch opened from a C-phase-to-ground fault in Zone 6.

After both Gen-sets A1 and B1 were running for a few minutes and supplied power to Load Banks 3 and 5, the test started with a “Start” command from the EMS. As soon as the static switch closed and steady-state conditions established, the microgrid and Load Bank 6 were connected to the utility grid with the total power flow at Meter 1 being approximately 89kW, shown in Figure 21a, and approximately 35kW at Meter 2, shown in Figure 21b. Before the overload fault was applied, Gen-set A1 was producing approximately 17kW and Gen-set B1 was producing approximately 19kW, shown in Figures 21c and 21d, respectively.

Within the islanded microgrid, Gen-sets A1 and B1 increased their output power to Load Banks 3 and 5. Gen-set A1 increased its output power from approximately 17kW to 34kW, and Gen-set B1 increased its output power from approximately 19kW to 36kW, shown in Figures 21c and 21d, respectively. Meter 2 (i.e., Figure 21b) power flow decreased to 0kW after the fault was initiated and the static switch opened. After the overload fault was cleared from the electrical system, Meter 1 (i.e., Figure 21a) power flow decreased to 80kW from the utility grid. The utility grid and microgrid remained in this stable state until the fault was removed.

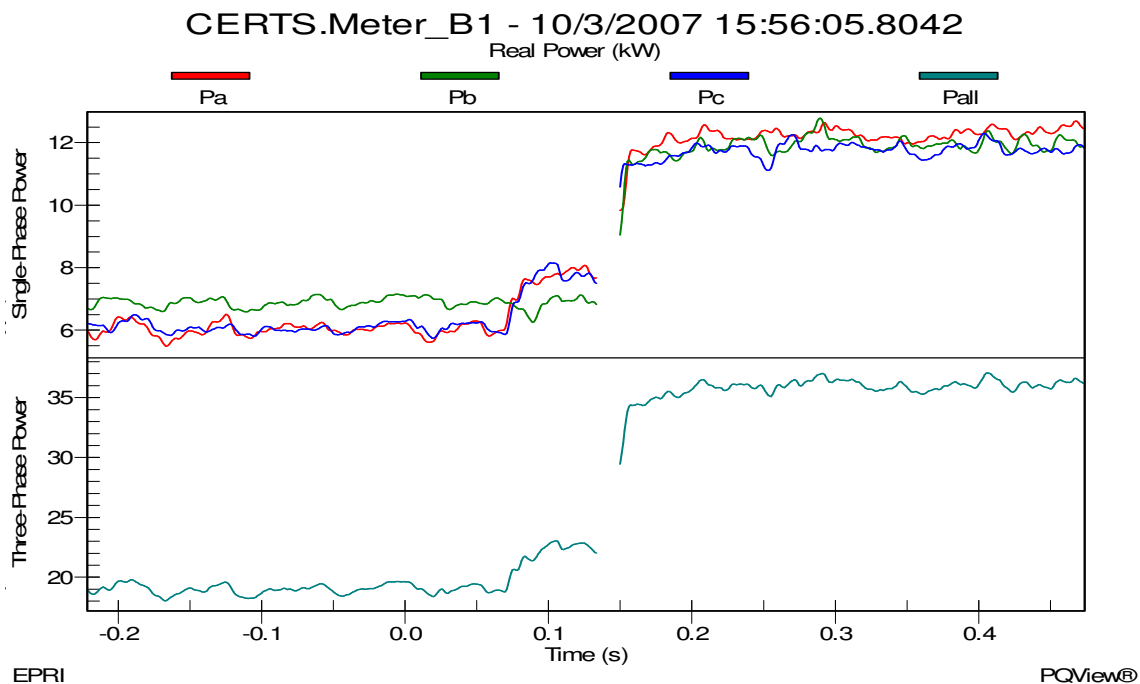
**Figure 21d - Power produced by Gen-set B1 before/after the static switch opened from a C-phase-to-ground fault in Zone 6.**

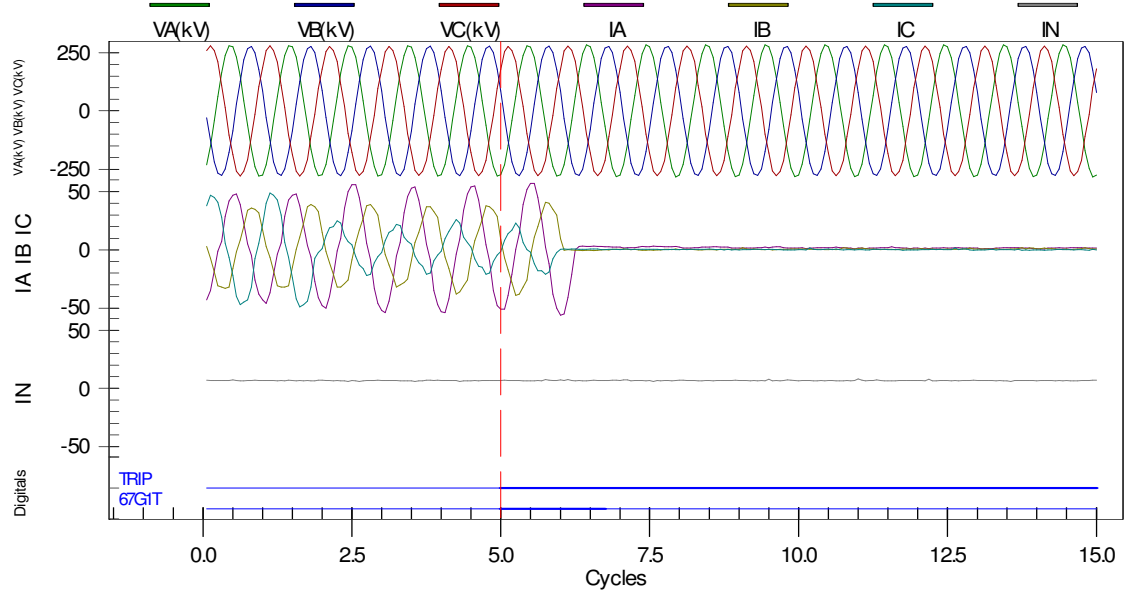
**Figure 21e - Relay 2 (static switch) tripped due to a neutral over-current (67G1T) when the single phase-to-ground fault was initiated in Zone 6.**

Using the DAS Load Control program, the single phase-to-ground fault on C-phase was set for 10 seconds and then initiated. The static switch tripped in approximately 0.07 seconds (~4.3 cycles) from a neutral over-current (67G1T), shown in Figure 21e, islanding the microgrid from the utility grid. Following the static switch operation, CB13, which provides protection to Zone 6, tripped on  $I^2t$  protection with CB31, CB41 and CB51 remaining closed, since the overload fault was not part of the microgrid, located beyond the static switch.

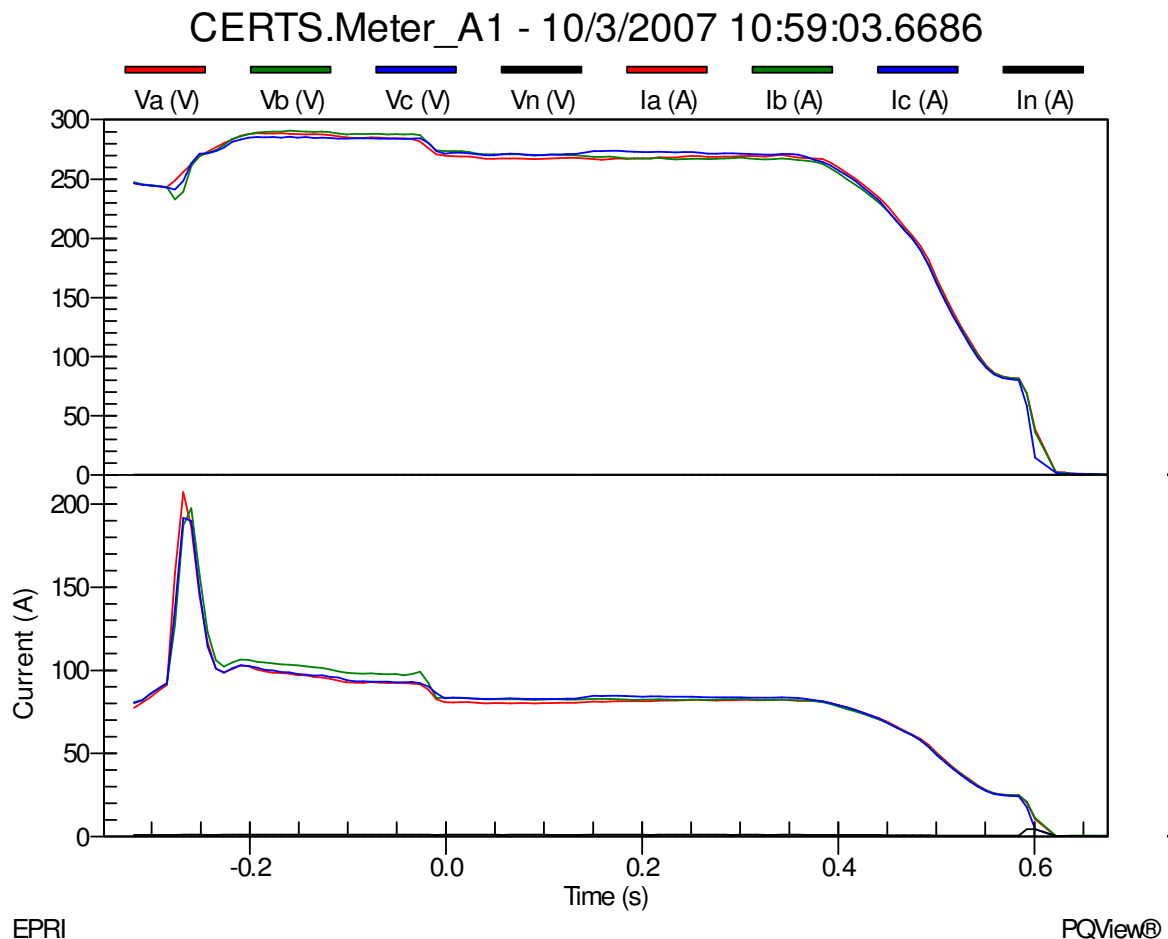
Figure 21h – Gen-set A1 shutting down due to a “No Field” fault.

In Figure 21h, voltage at Gen-set A1 suddenly dropped to 245V and current increased to approximately 200A. After a short period of time, 0.28 seconds, Gen-set B1 was removed from the system and Gen-set A1 remained on-line, now serving both Load Banks 3 and 5, measured at approximately 65kW. Gen-set A1 continued to serve this load for approximately 0.38 seconds and then shut down, unexpectedly. Two conditions need be examined; the sudden import of power into Gen-set B1 which initiated the problem, and the short duration of Gen-set A1 operation afterwards which should have been within its overload envelope capability. These problems need to be corrected, as they unintentionally lead to a decrease in reliability.

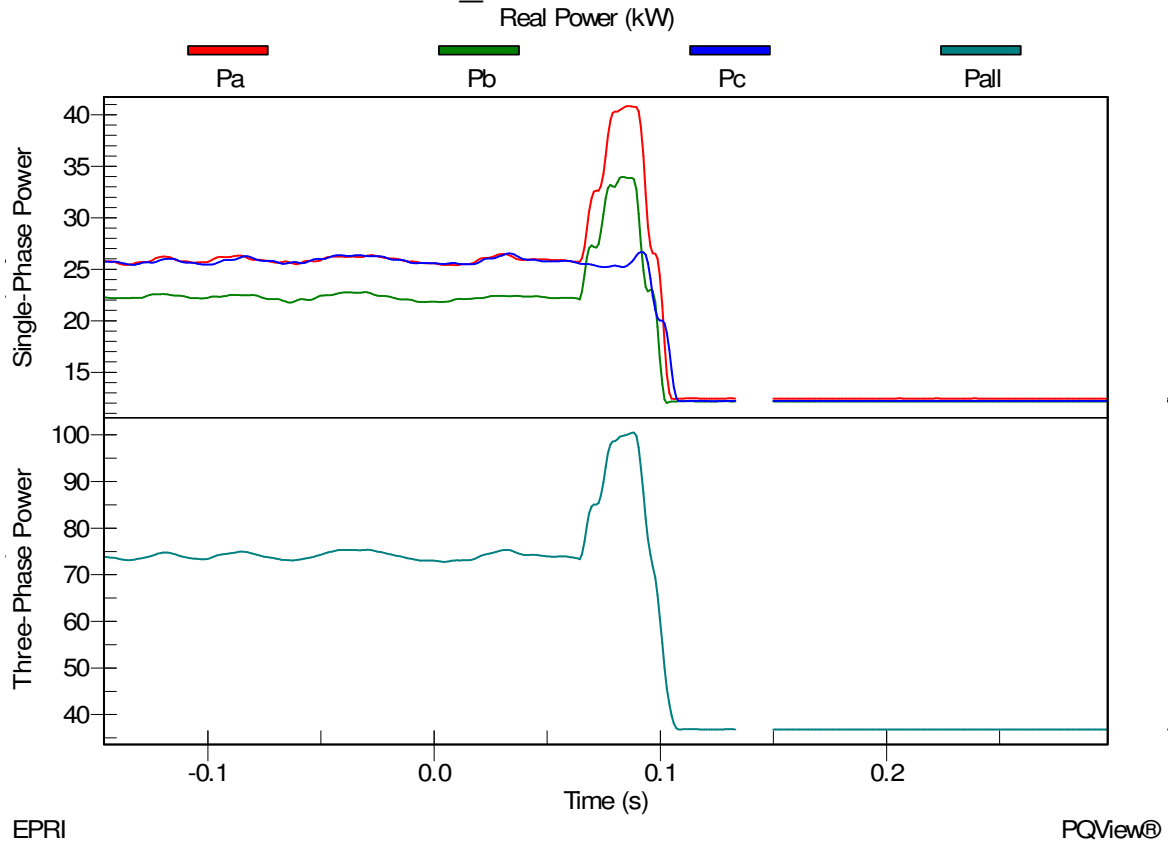
Figure 22a – Meter 1 power flow before/after the static switch opened, islanding the microgrid from the utility grid when the phase-to-phase fault was applied in Zone 3.

Using the DAS Load Control program, the phase-to-phase fault on A and B phases was set for 10 seconds and then initiated. The static switch tripped in approximately 0.028 seconds (~1.7 cycles) from a negative-sequence over-current (67Q1T), shown in Figure 22e, islanding the microgrid from the utility grid. CB31, CB41 and CB51 remained closed throughout the 10 second phase-to-phase fault. Gen-sets A1 and A2 increased their output power from approximately 19kW to 54kW, each shown in Figures 22c and 22d supplying power to Load Banks 3 and 4. Load Bank 6 was supplied power from the utility grid, shown in Figure 22a.

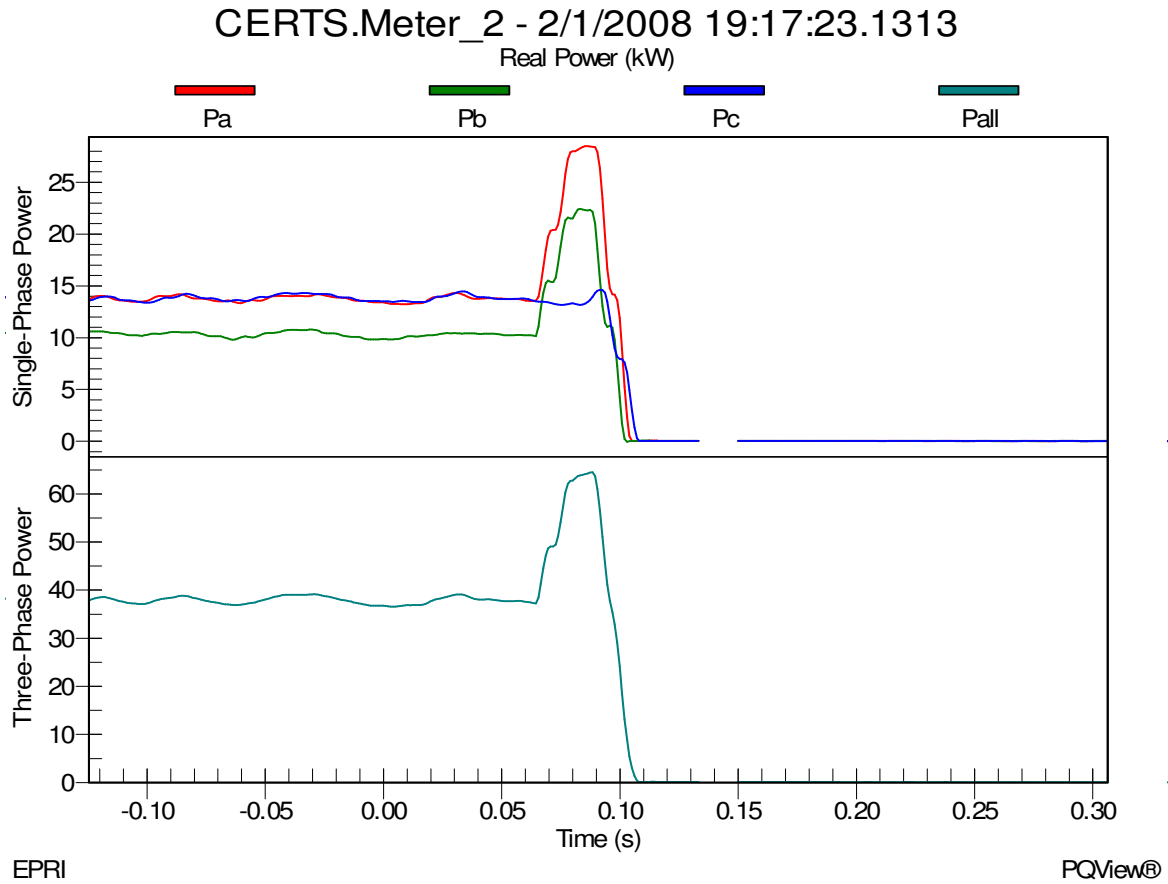
Figure 22b – Meter 2 power flow before/after the static switch opened, islanding the microgrid from the utility grid when a phase-to-phase fault was applied in Zone 3.

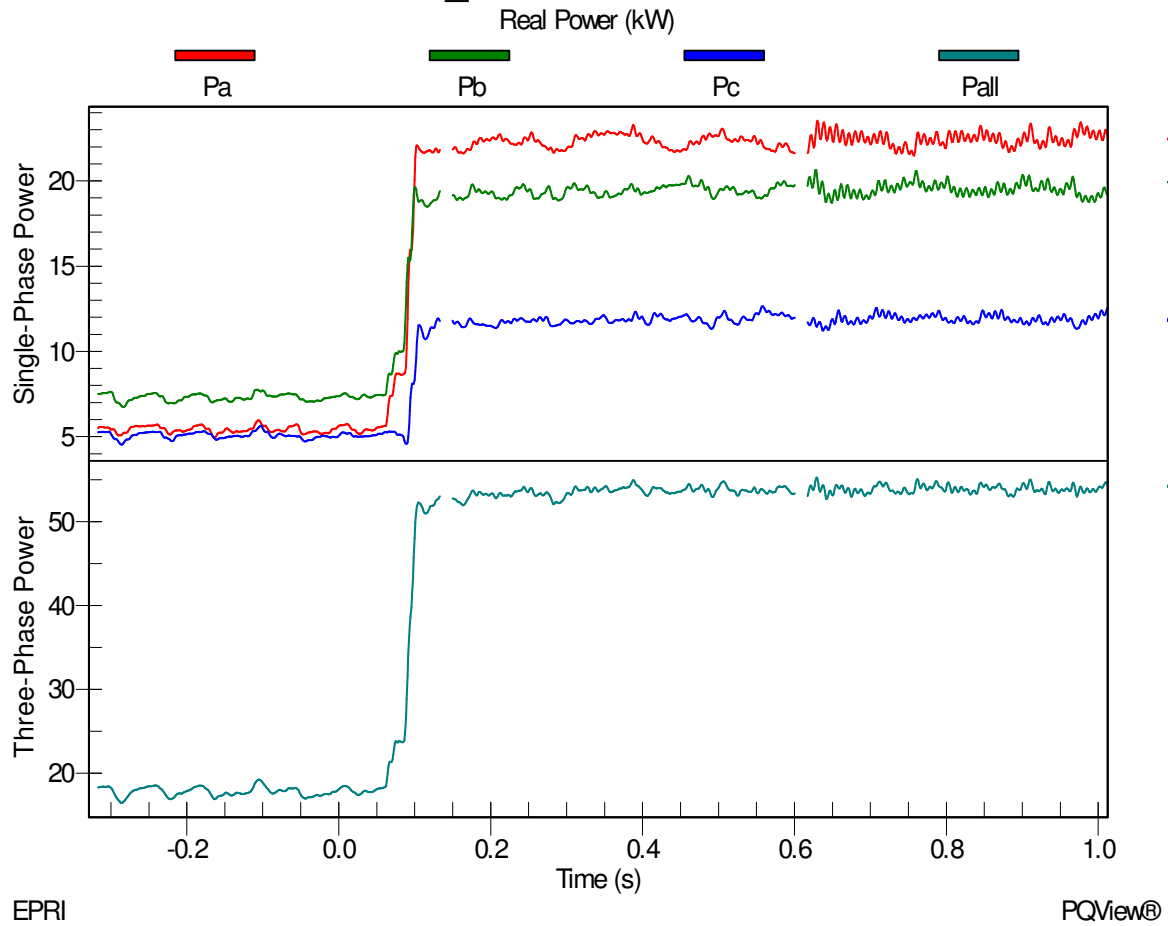
Figure 225c - Power produced by Gen-set A1 before/after the static switch opened when an A-to-B phase fault was applied in Zone 3.

After Gen-sets A1 and A2 were running for a few minutes and supplied power to Load Banks 3 and 4, the test started with a “Start” command from the EMS. As soon as the static switch closed and steady-state conditions established, the microgrid and Load Bank 6 were connected to the utility grid with power flow at Meter 1 being approximately 74kW, shown in Figure 22a, and approximately 38kW at Meter 2, shown in Figure 22b. Before the overload fault was applied, Gen-sets A1 and A2 were producing about 19kW, shown in Figures 22c and 22d.

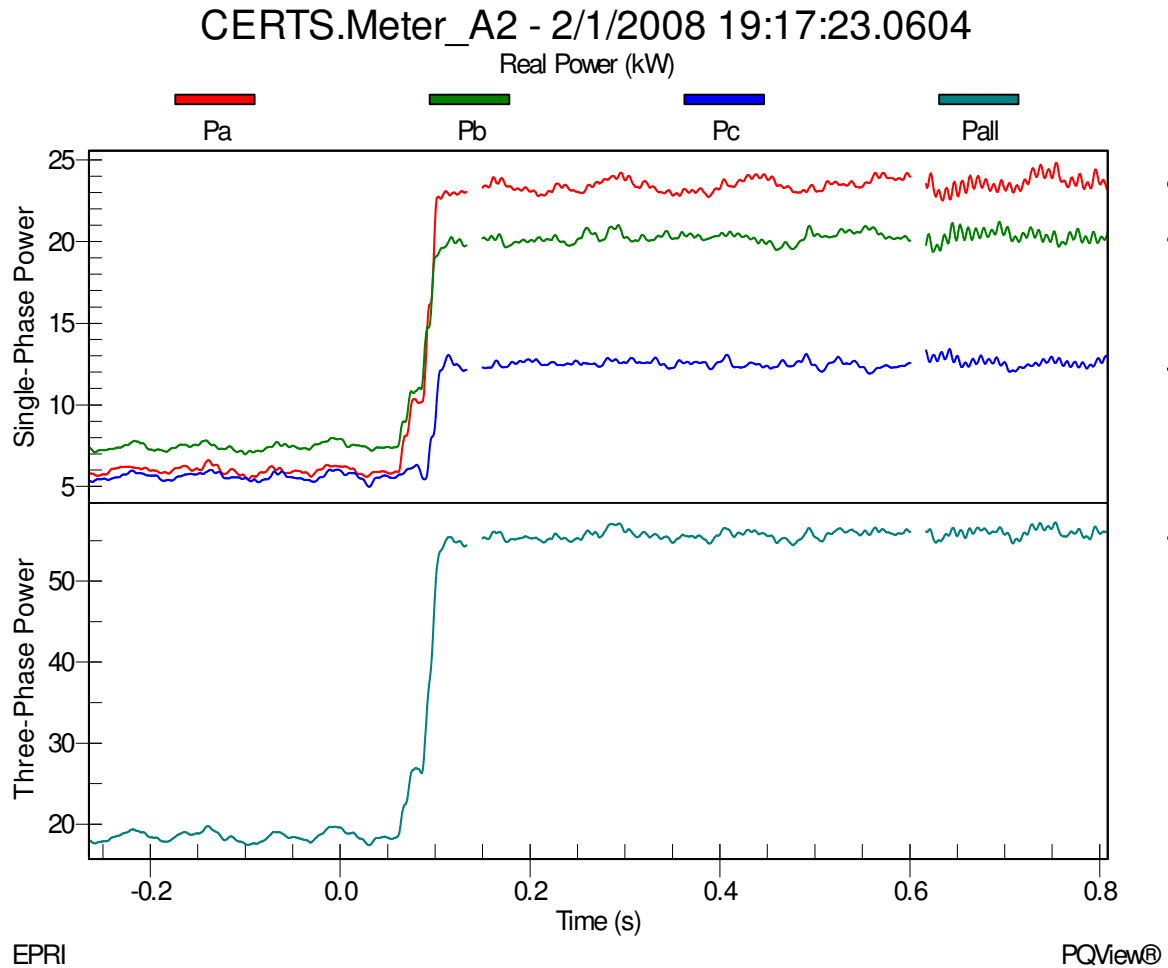
Figure 22d - Power produced by Gen-set A2 before/after the static switch opened when an A-to-B phase fault was applied in Zone 3.

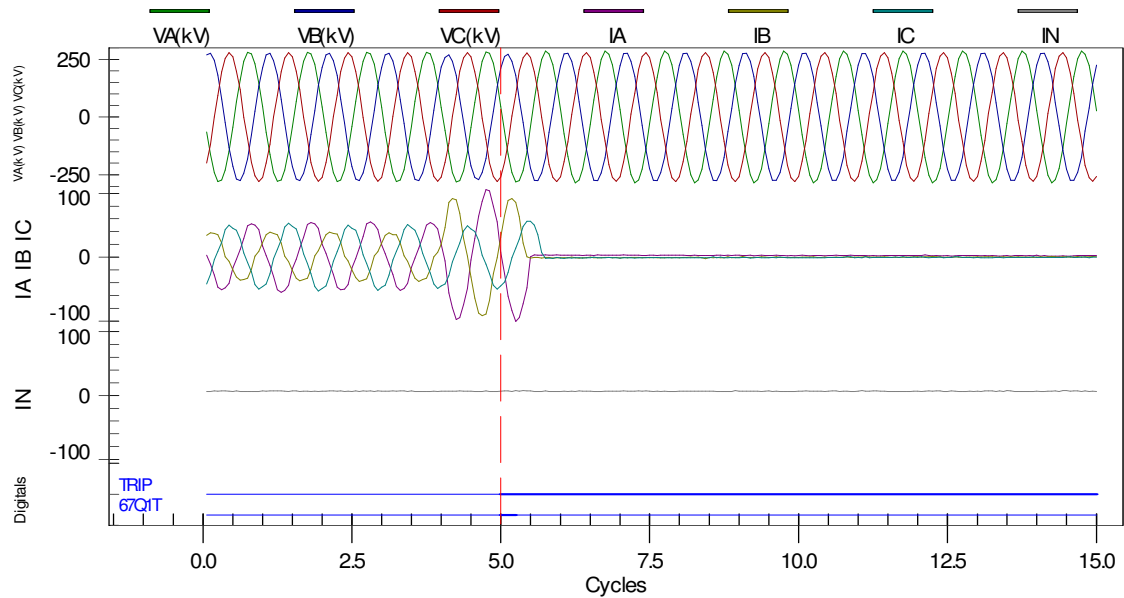
**Figure 22e - Relay 2 (static switch) tripped due to a negative-sequence over-current (67Q1T) when the phase-to-phase fault was initiated in Zone 3.**

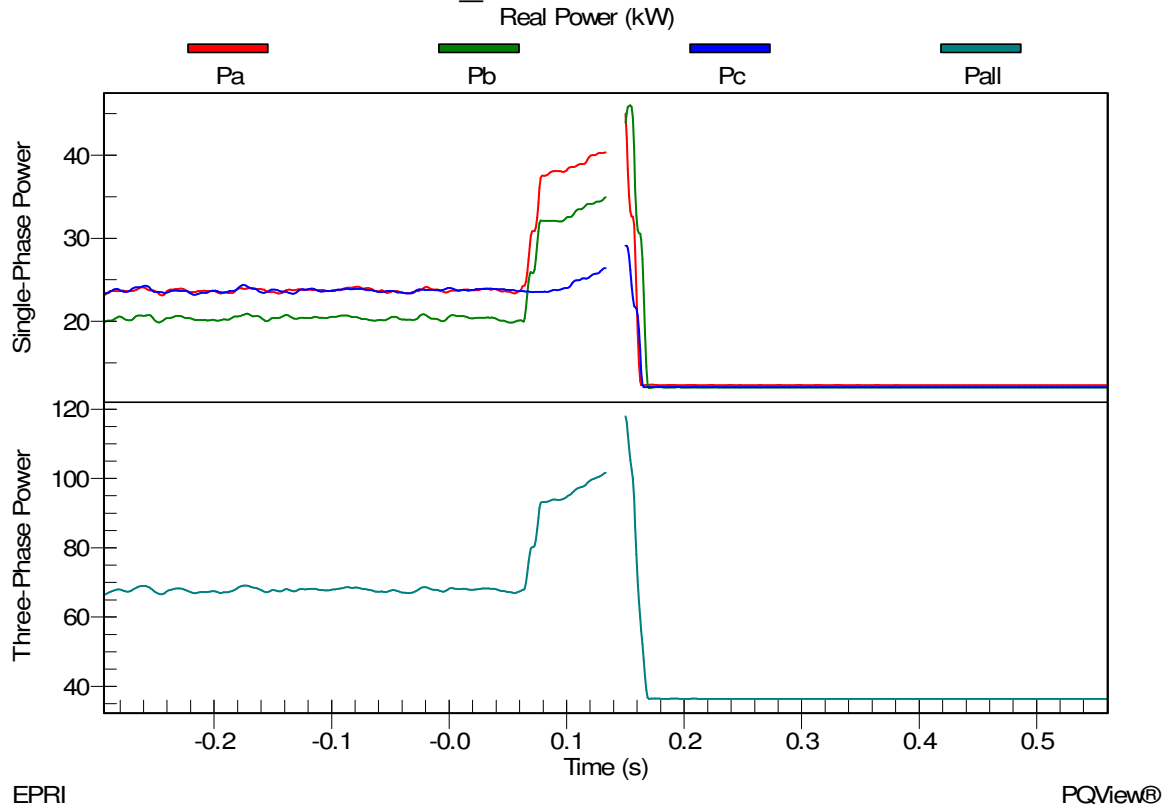
Figure 23a – Meter 1 power flow before/after the static switch opened, islanding the microgrid from the utility grid when a phase-to-phase fault was applied in Zone 4.

Using the DAS Load Control program, the phase-to-phase fault on A and B phases was set for 10 seconds and then initiated. The static switch tripped in approximately 0.078 seconds (~4.7 cycles) from a negative-sequence over-current (67Q1T), shown in Figure 23e, islanding the microgrid from the utility grid. CB41 tripped, after the static switch opened, due to a negative-sequence over-current (67Q1T) isolating Zone 4 from the rest of the microgrid, and shutting down Gen-set A2, shown in Figures 23d and 23f. CB31 and CB51 remained closed throughout the 10 second phase-to-phase fault. Gen-set A1 increased its output power from approximately 20kW to 35kW, shown in Figure 23c, supplying power to Load Bank 3. Load Bank 6 was supplied power from the utility grid, shown in Figure 23a.

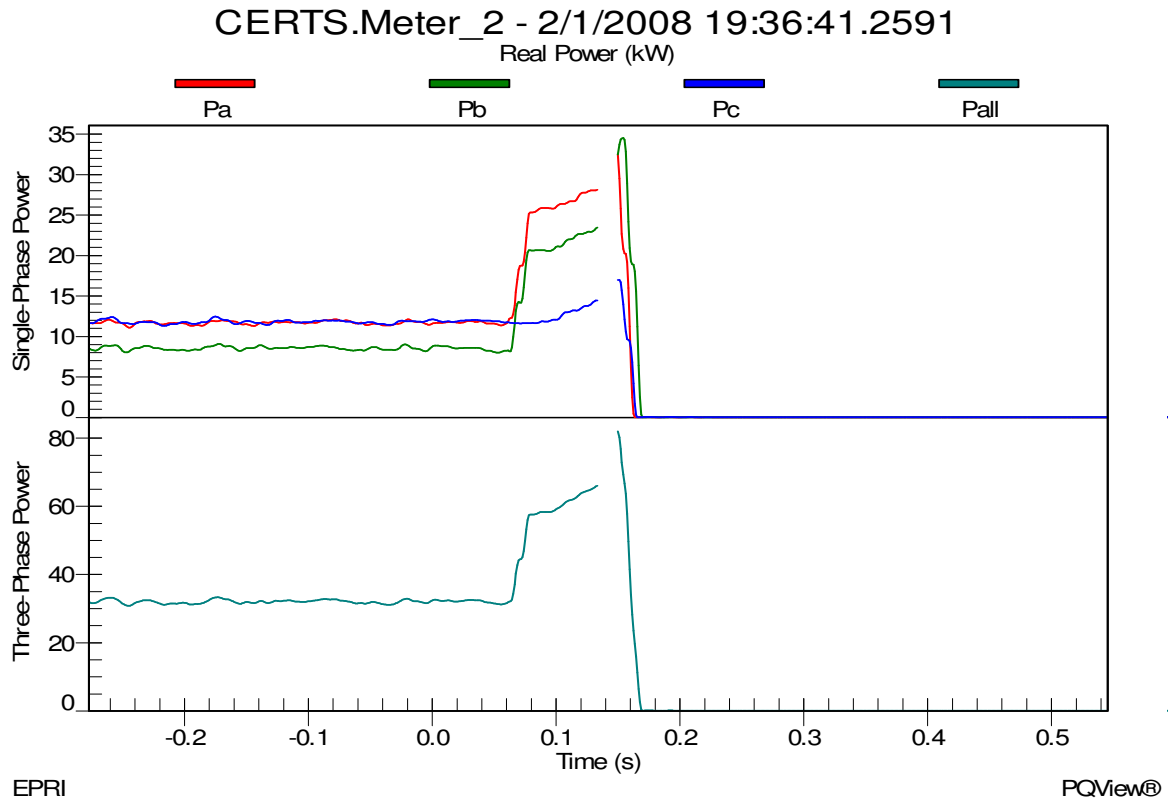
Figure 23b – Meter 2 power flow before/after the static switch opened, islanding the microgrid from the utility grid when a phase-to-phase fault was applied in Zone 4.

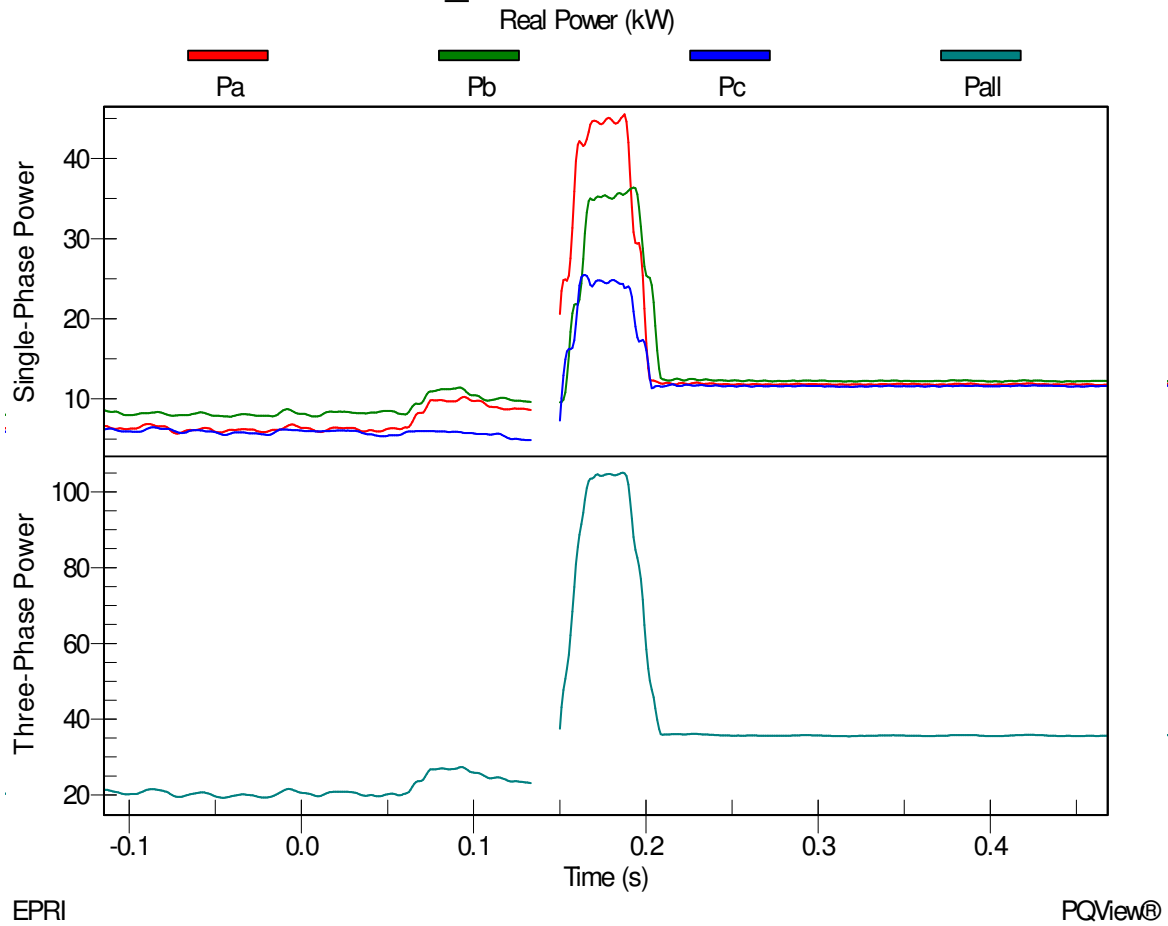
Figure 23c - Power produced by Gen-set A1 before/after the static switch opened when an A-phase to B-phase fault was applied in Zone 4.

After Gen-sets A1 and A2 were running for a few minutes and supplied power to Load Banks 3 and 4, the test started with a “Start” command from the EMS. As soon as the static switch closed and steady-state conditions established, the microgrid and Load Bank 6 were connected to the utility grid with power flow at Meter 1 being approximately 67.5kW, shown in Figure 23a, and approximately 36kW at Meter 2, shown in Figure 23b. Before the overload fault was applied, Gen-sets A1 and A2 were producing about 20kW, each shown in Figures 23c and 23d .
